Royal
Botanical
Gardens
CANADA

2022 Status Update of Fish and Wildlife Populations and their Habitat in Cootes Paradise and Grindstone Coastal Marshes in support of HHRAP

Tys Theijsmeijer
Aleksandra Rebalka
Jennifer Bowman
Ecological Stewardship Department
Royal Botanical Gardens
June 2024
Royal Botanical Gardens
P.O. Box 399
Hamilton, ON L8N 3H8
Canada

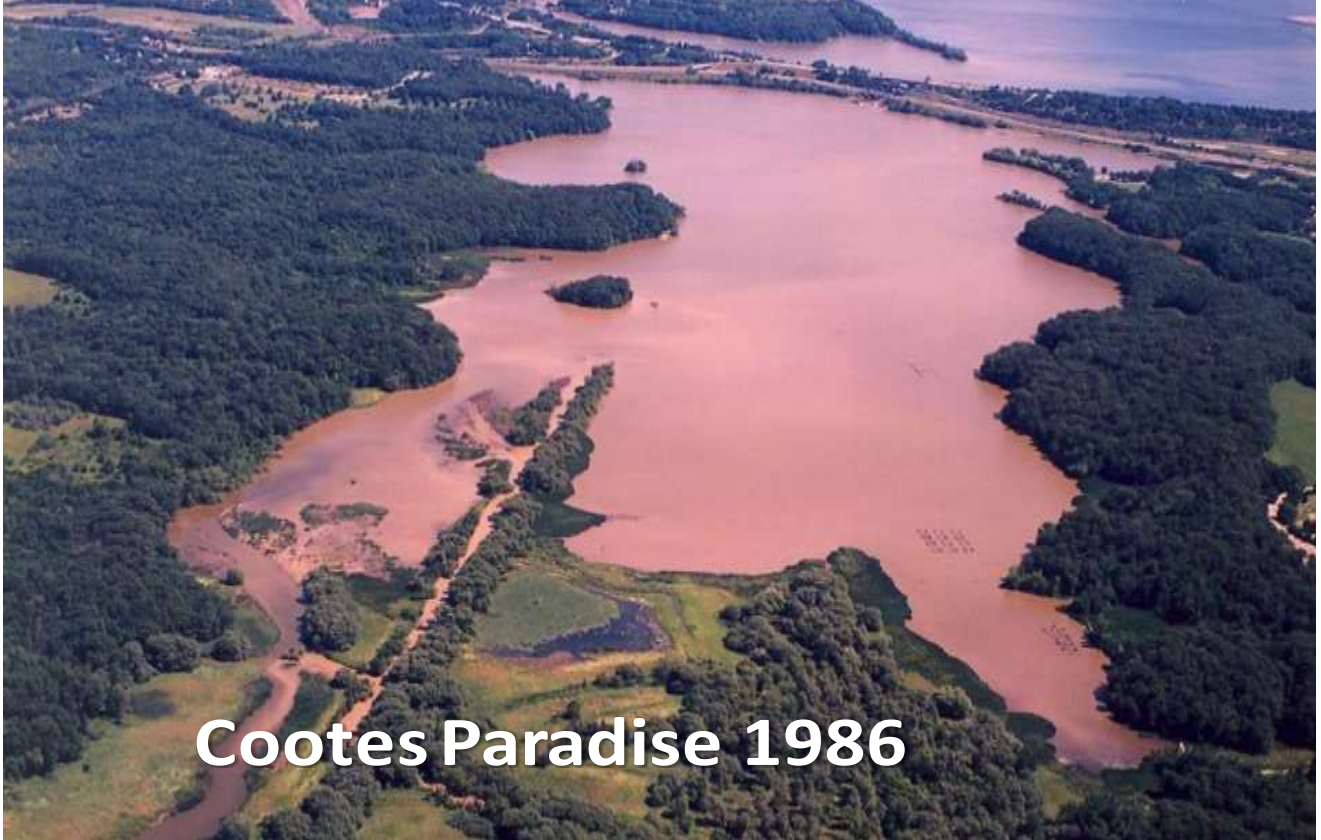
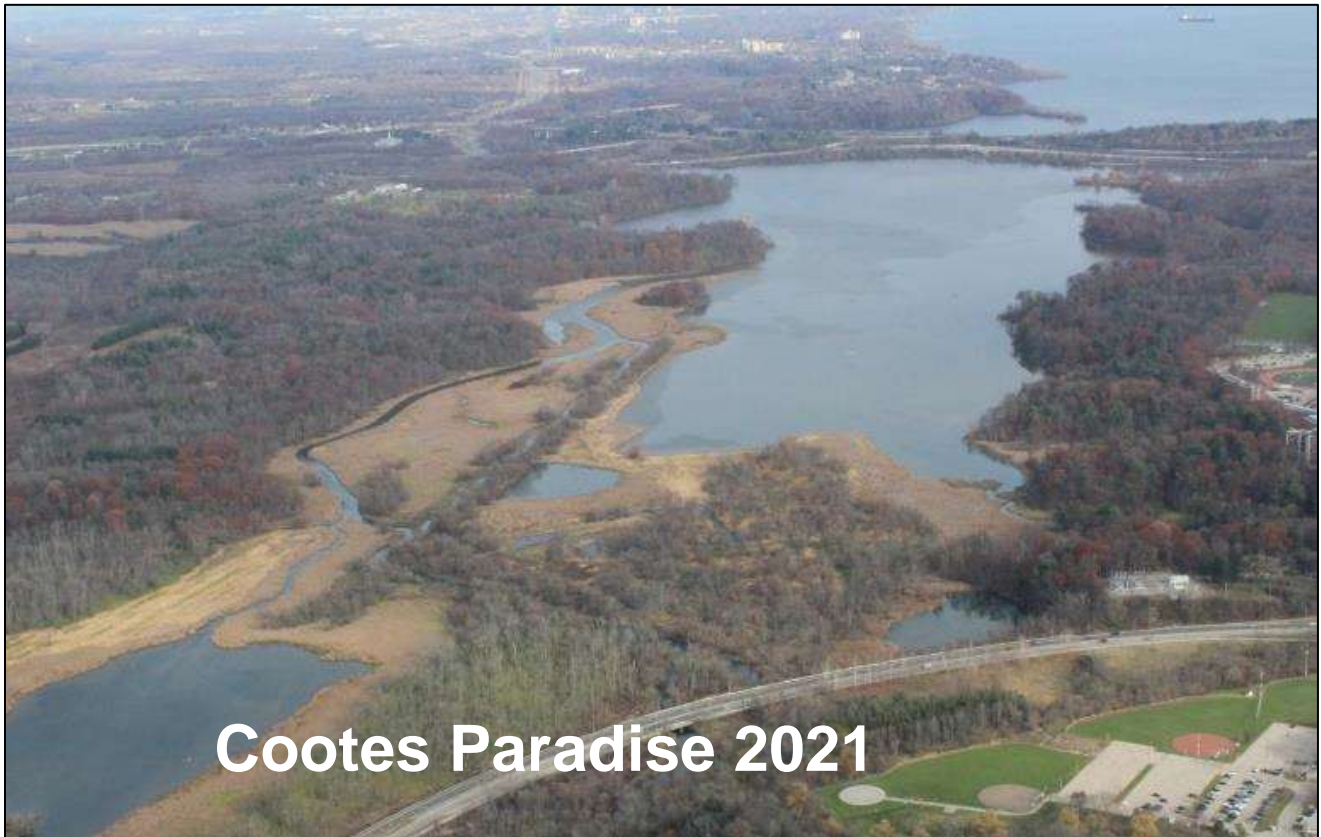
Aerial View of Cootes Paradise Marsh at the initiation of the HHRAP and in spring 2021.

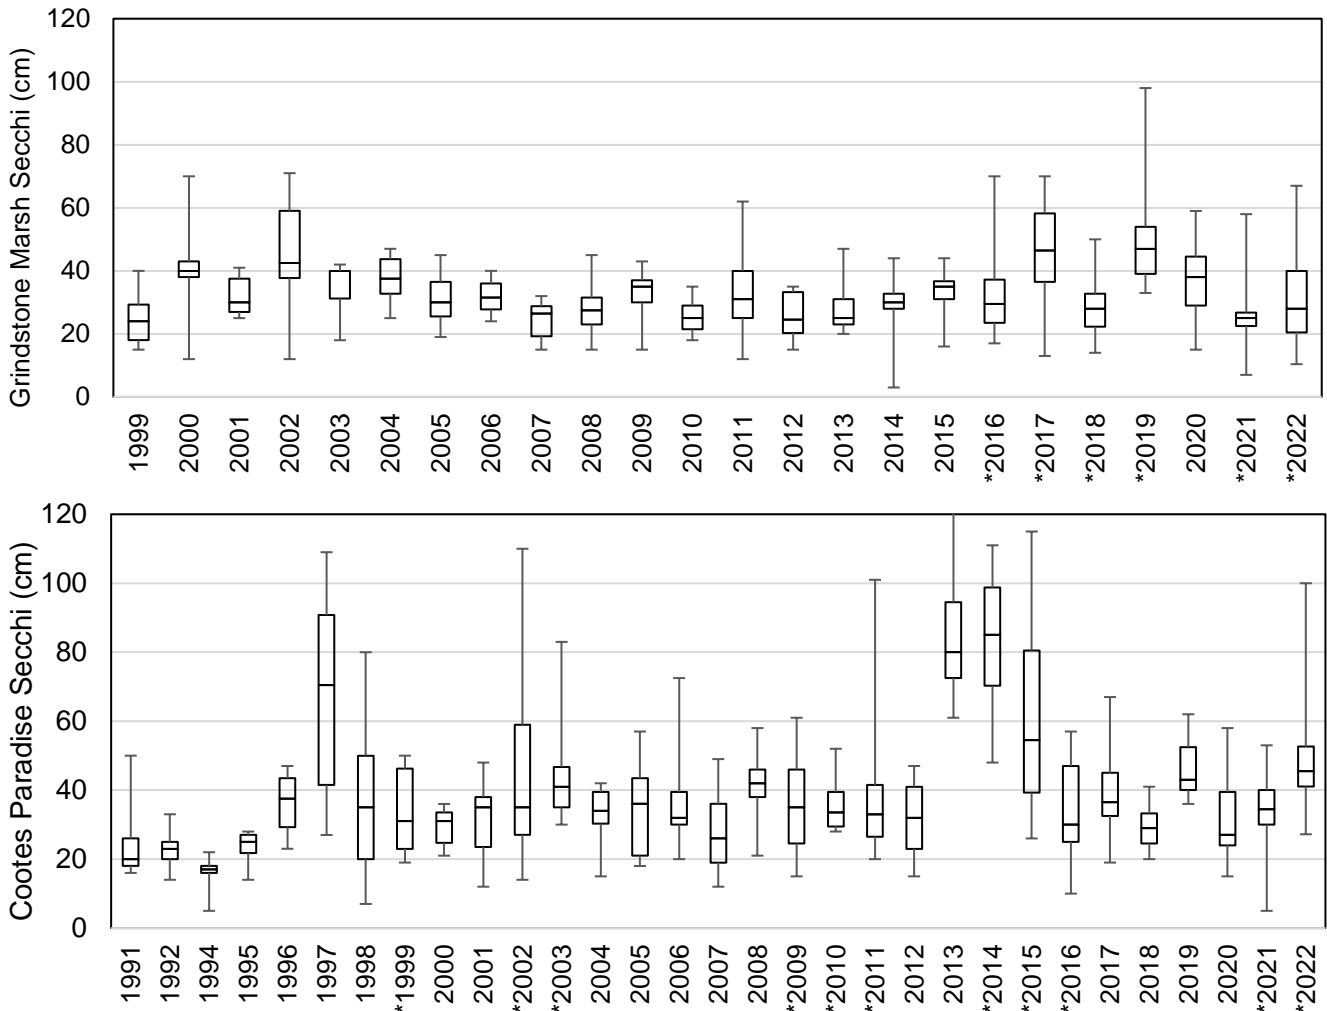
Figure 2 Water clarity (secchi depth) spring and summer samples for Cootes Paradise (above) and Grindstone Marsh (below) delisting stations (CP2, GC1) from 1991 to 2022. *Data include occasion on the bottom result.

Water clarity while improved is generally less than 50 cm Secchi depth (Figure 2) and dissolved oxygen is impaired (Figure 3, Figure 4), and regularly less than 5mg/l during the summer season. Dissolved oxygen is occasionally near zero in midwater column, and at times is also supersaturated stressing aquatic biota, approaching 20 mg/L. This supersaturation is most notable in Cootes Paradise’s West Pond area located immediately downstream of the Dundas WWTP. Water clarity is not measured within the interior shelter pond areas but is generally observed to be clear as long as carp exclusion is maintained. At times during the spring as noted in the figures water clarity does occasionally exceed 1m of visibility in the centre station monitoring sites for Cootes Paradise Marsh. For Grindstone Marsh only during the record high water levels of 2019 did water clarity notably improve.

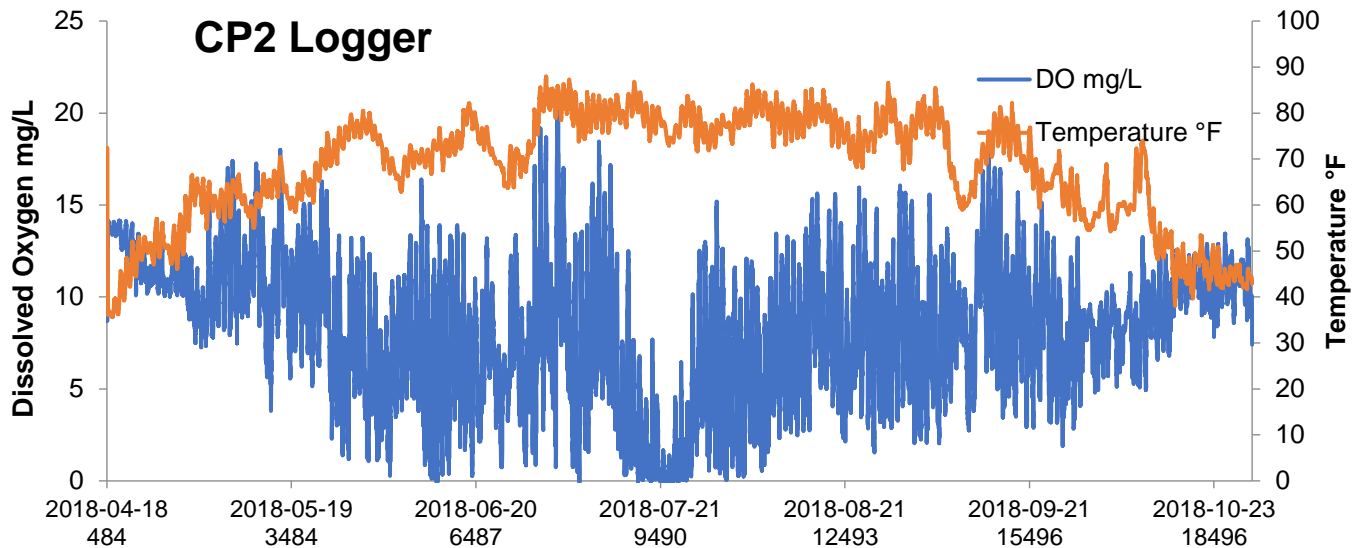
Figure 3. Temperature and Dissolved Oxygen (DO) example from a D.O. Loggers project in 2018 at delisting centre station CP2 of Cootes Paradise Marsh illustrating the fluctuations seen in oxygen.

instances where D.O. has been below 4 mg/L throughout the sampling year, most notably in 2018 during the large-scale raw sewage spill from Chedoke Creeks Main-King CSO tank. Large swings in D.O. are also characteristic of impacted eutrophic aquatic systems. Cootes Paradise continues to experience large daily swings in D.O., especially in the most sewage impacted areas of West Pond and Chedoke Creek (Bowman, 2020). Supersaturation is more associated with algal blooms or extremely dense vegetation, and aquatic plant recovery may ameliorate the issue in the nearer term. Some fluctuation in D.O. is characteristic of a healthy marsh.

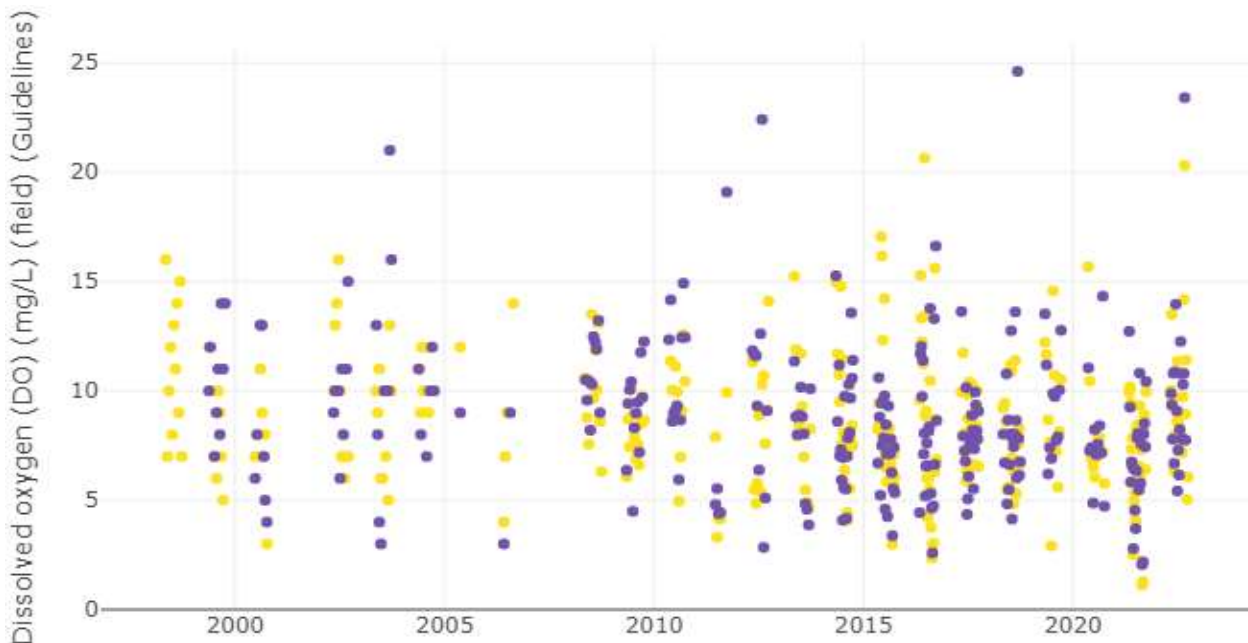
Figure 4 Dissolved Oxygen (DO) values measured in mg/L at HHRAP delisting stations about mid-day between May and October at CP2 (yellow) and GC1 (purple). Plot taken from RBG dataset on Great Lakes Datastream (<https://greatlakesdatastream.ca>)

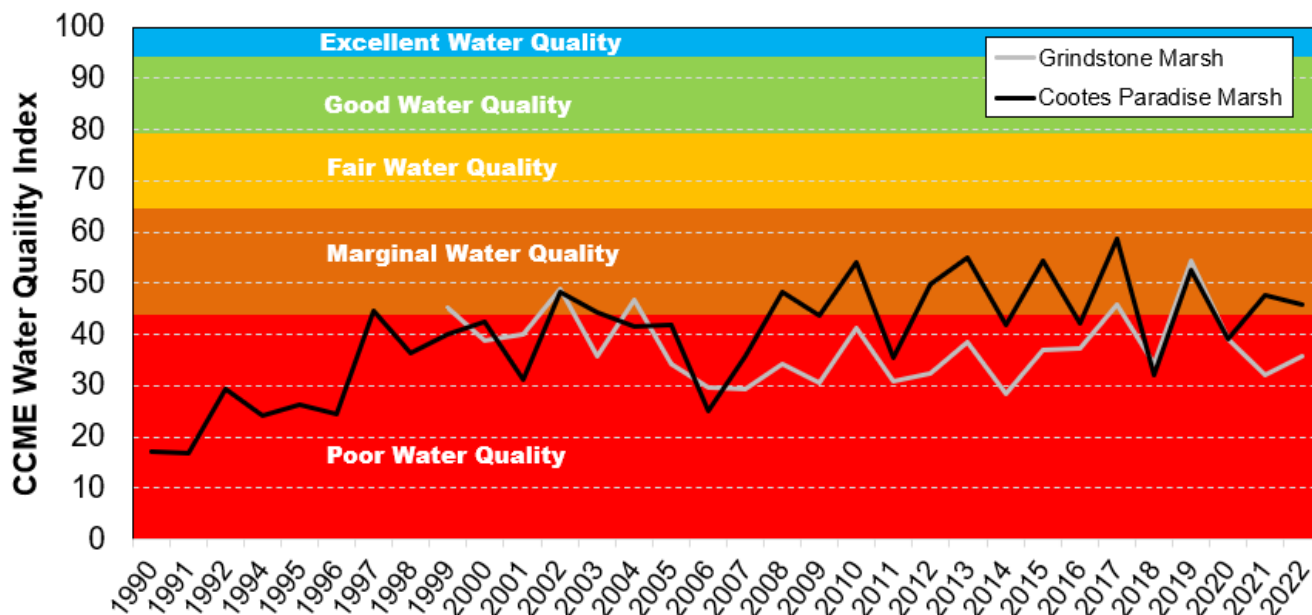
Figure 5. Canadian Council of Ministers of the Environment (CCME) Water Quality Index score coastal marsh centre stations (HHRAP delisting station - GC-1, CP-2 – May to September data) using the subset of parameters of Nitrate-N, Inorganic Suspended Sediment (ISS), Total Suspended Sediment (TSS), Total Phosphorus, *E. coli*, and Dissolved Oxygen. Scores >90 = appropriate clean water.

A water quality index (WQI, by CCME) for both marsh delisting stations summarize the water quality parameters into a single value and indicates improved but marginal water quality conditions on average. The WQI version used incorporates total nitrate as N, inorganic suspended solids, total suspended solids, total phosphorus, *E. coli* and D.O. (Bowman, 2022). Good quality water scores are 90-100 for the index. Water quality conditions rate as marginal with a score in the 50s currently. The WQI indicates an inconsistent, but positive trend in Cootes Paradise, with an improvement from 2021 to 2022 (Figure 5). However, the last three years' values were poor (2021-low water) to marginal (2020 and 2022), meaning that Cootes Paradise is consistently impaired but perhaps close to a tipping point. In Grindstone Marsh, the WQI was slightly better, producing values that were consistently marginal, but perhaps with a slight decline over the past 20 years (Figure 5).

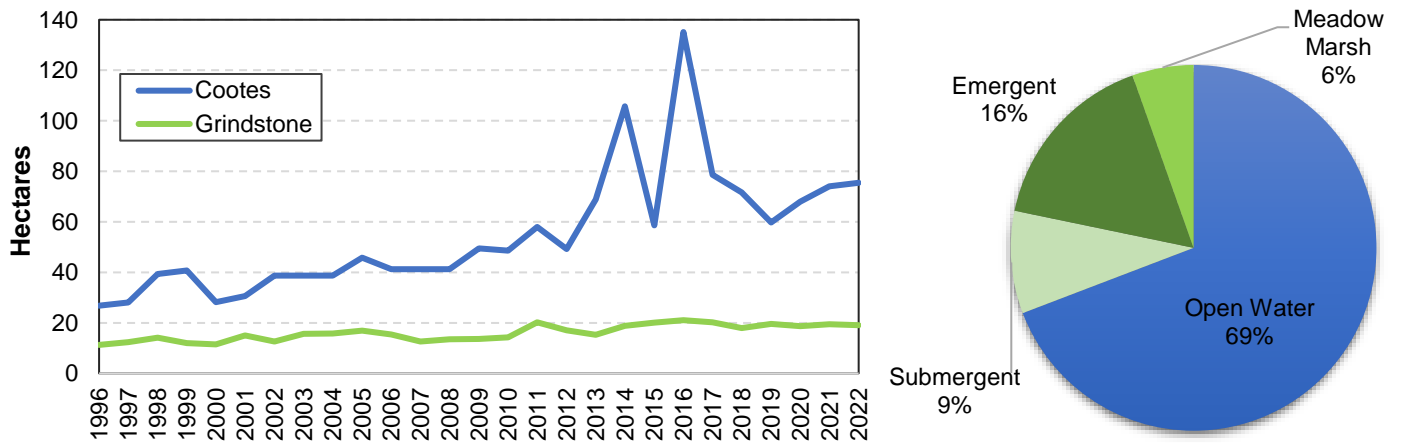
Figure 6a. Total marsh vegetation area trends in Cootes Paradise and Grindstone Marsh. Cootes Paradise Marsh delisting target 230ha., and Grindstone Marsh delisting target is 40ha. Figure 3b. The 2022 Coastal marsh area breakdown between different vegetation types (Cootes Paradise and Grindstone Marsh combined).

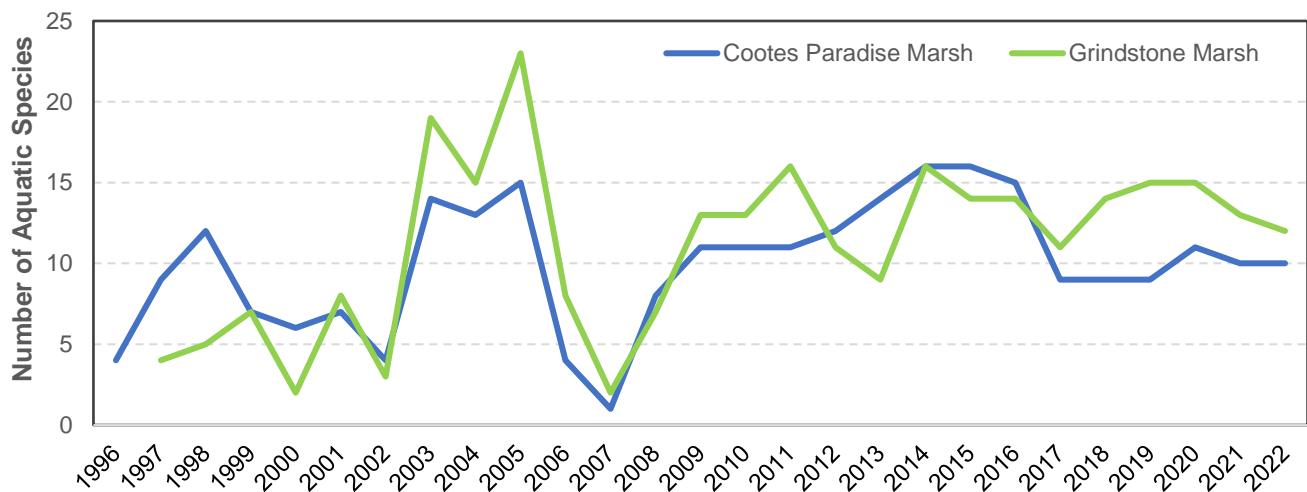
Figure 7. Annual plant species richness from aquatic monitoring quadrates in the marshes (early summer).

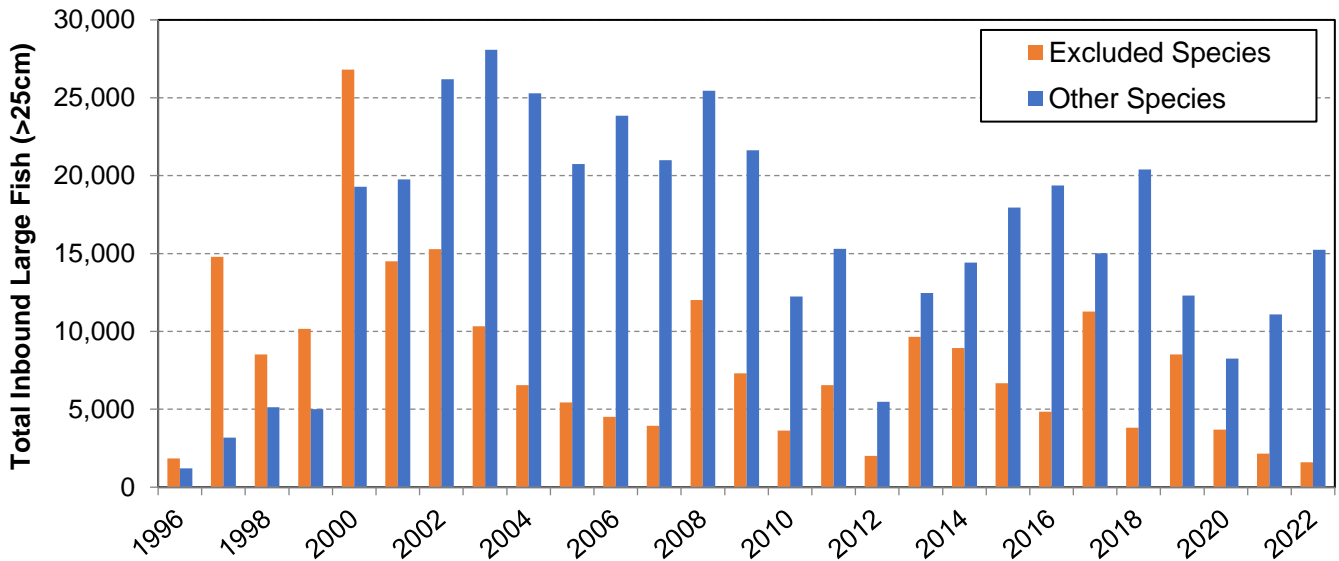
Figure 8. Annual number of inbound invasive species (excluded species) and native fish (other species) at Cootes Paradise Fishway. Excluded species includes Common carp, Goldfish, Carp x Goldfish hybrids, and Rudd.

Since the construction of the Fishway in 1996, there has been a noticeable decline in the number of Common Carp trying to enter the marsh. From 1996 – 2000, Common Carp represented most of the fish seen at the Fishway, reaching population numbers of over 20,000 (Figure 8). Common Carp for the last 5 years average about 3,000 carp are caught in the Fishway each year (Figure 8) as compared to numbers of 20,000 at the outset. A number of native species have significantly increased, as well as two invasive species - Rudd and Goldfish. For native species in recent years, Brown Bullhead and White Suckers have been the most prevalent species caught at the Fishway. Channel Catfish, Bowfin, Gizzard Shad and Freshwater Drum have maintained consistent population numbers within recent years, while Rainbow Trout, Northern Pike and Largemouth Bass have experienced (Table 2). Brown Bullhead, Gizzard Shad, and Bowfin have population many times that compared to the outset of the HHRAP, while Northern Pike are nearly extirpated. Species richness overall is also on the decline as measured in all fish monitoring activities (Figure 9).

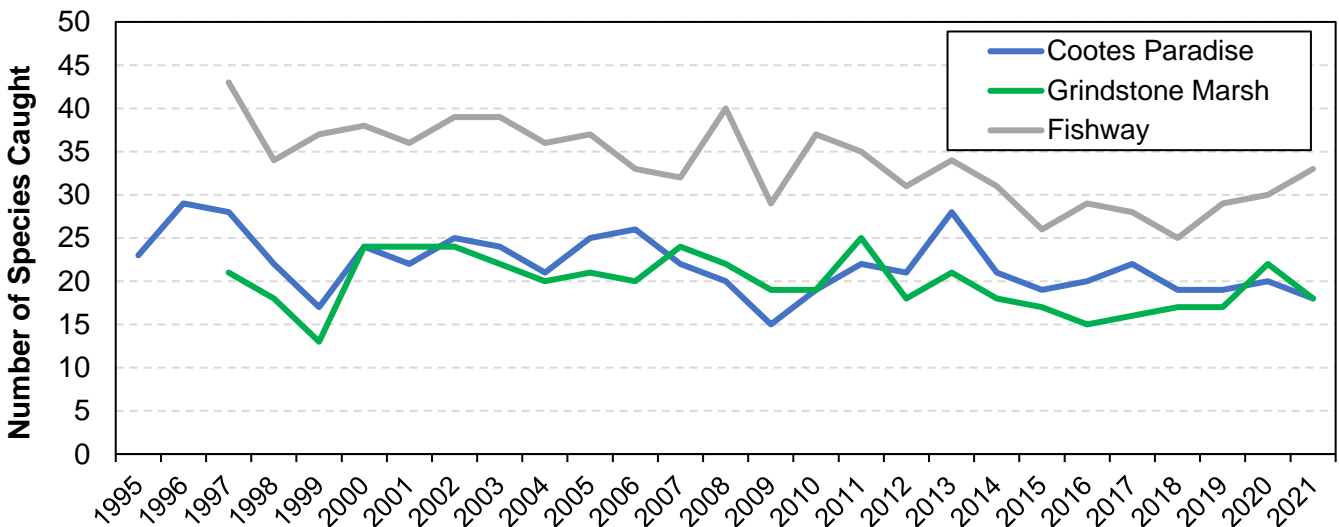
Figure 9. Total fish species found at the Fishway and during August index electrofishing index

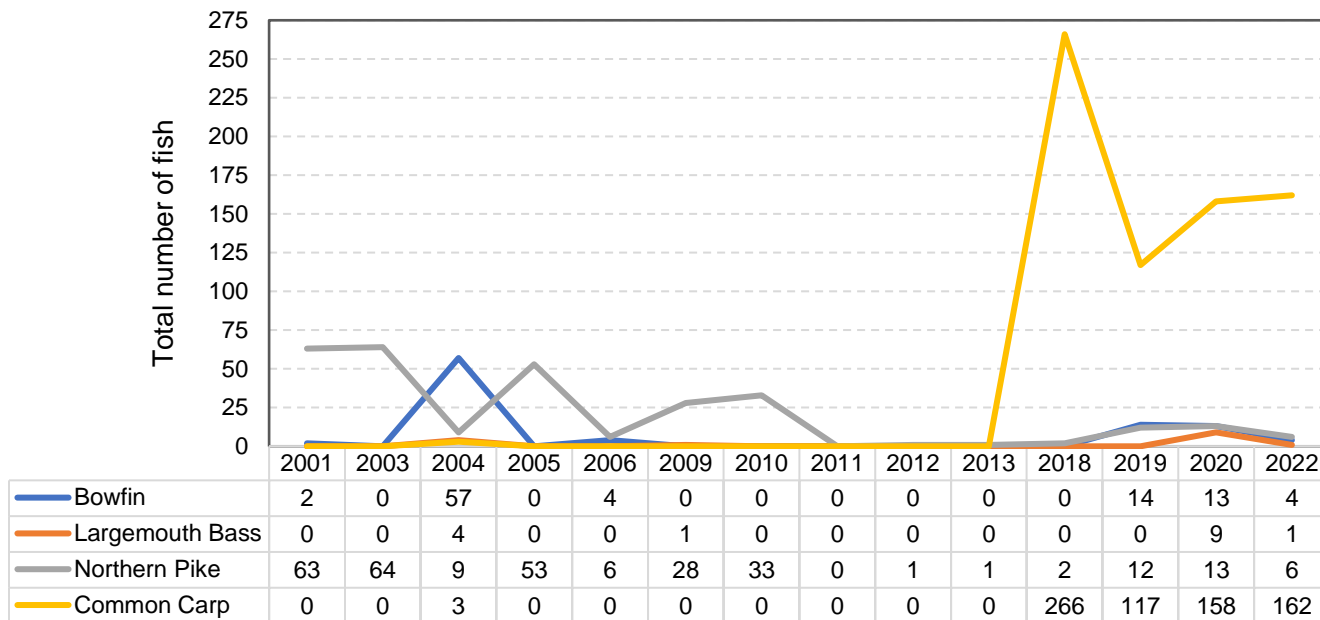
Figure 10. Total number of predatory fish caught each year in the pike trap monitoring, compared against Common Carp. (No monitoring occurred in 2002, 2007, 2008, 2014-2017, 2021)

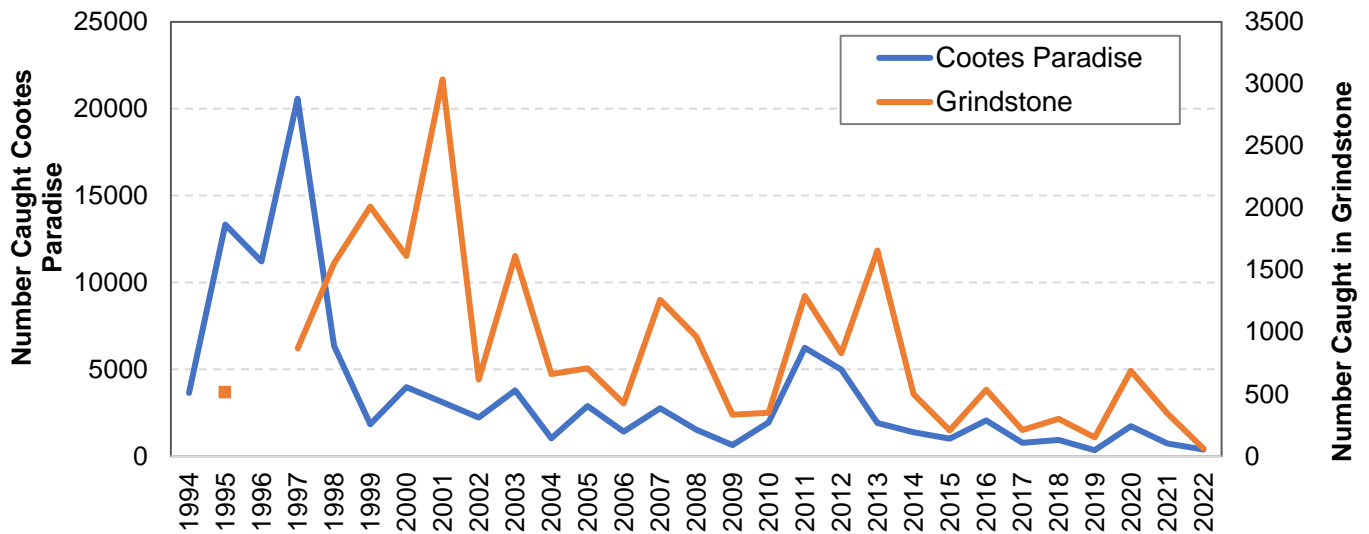
Figure 11. Total number of fish captured in Cootes Paradise and Grindstone marshes during annual electrofishing surveys. (No monitoring took place in Grindstone in 1994 and 1996)

During the electrofishing monitoring, there has been a general decline in the number of fish caught each year, except for 2020, where there was a rise in total catch (Figure 11). Upon further investigation it was concluded that this spike coincided with a large Bluegill and Pumpkinseed YOY success that influenced the numbers (Rebalka et al. 2023). The last big change in catch numbers occurred back in 2011 due to high water levels, allowing for floodplain inundation (Epp & Court, 2012). Mean number of YOY fish caught/ transect has remained relatively low over the last 9 years, not reaching a value of 20 YOY fish/transect since 2013 (Figure 12). Positively, YOY Common carp/transect has remained below 1 fish/transect since 2013, and in 2022, no YOY carp were found in either Marsh system through monitoring (Figure 14, Tables 3 &4).

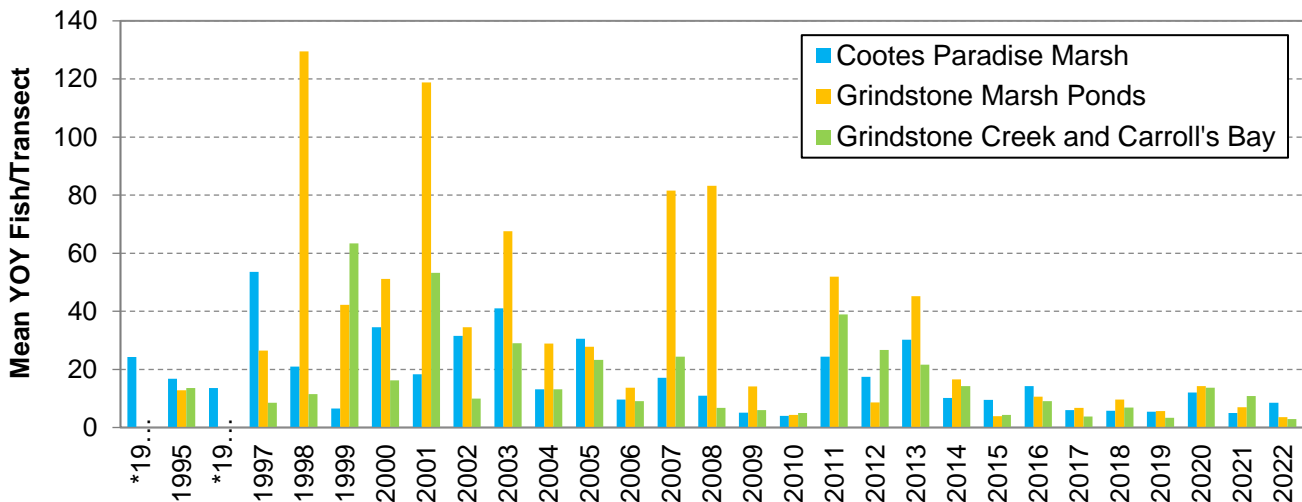
Figure 12. Mean Young of the Year (YOY) fish per transect, by year, for Cootes Paradise Marsh, Grindstone Marsh Ponds, and Grindstone Creek and Carroll's Bay Marsh (Outer Grindstone Marsh).

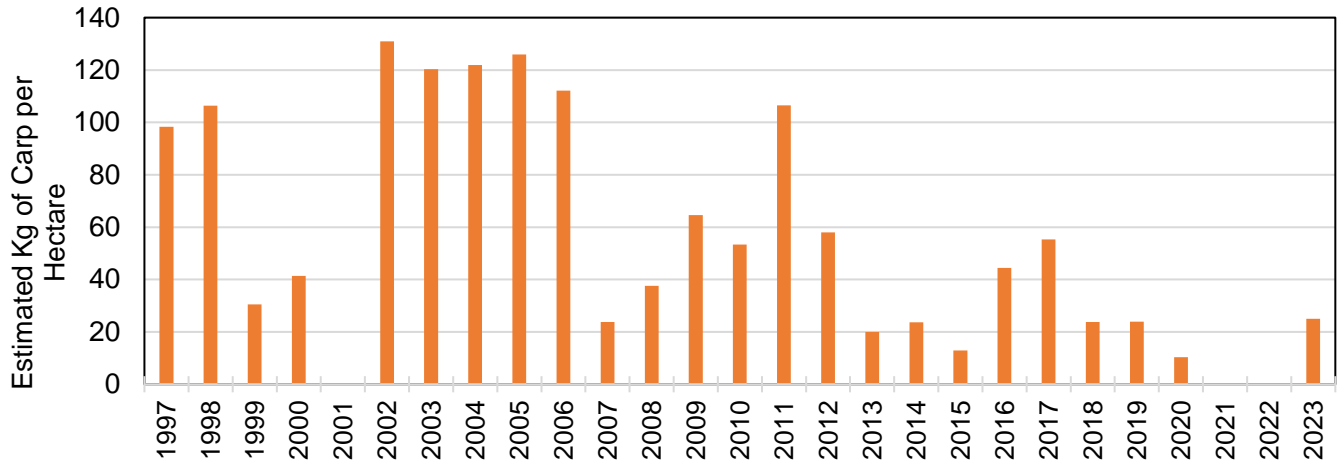
Figure 13. Estimated large carp biomass (fish >30cm fork length) in Cootes Paradise since the carp barrier initiated in 1997. Target is <20kg/ha, with per barrier densities of carp estimated at 800kg/ha. Estimated based on index electrofishing results

The Cootes Paradise Fishway initiated operation in 1997 significantly lower marsh biomass (Figure 13). Berms were built to exclude carp from a portion of Grindstone Marsh starting in 2000. Current densities are less than 5% of densities at the outset of the HHRAP. To maintain/achieve a low density of carp removal of large carp from these marsh areas has been necessary due to barrier issues as well as the growth of new younger carp. Since 2000, RBG has removed 40,037 large carp (>30cm fork length) from just Cootes Paradise Marsh alone. This doesn't include fish that are prevented from entering at the Fishway or Young of Year found (Figure 15). Additionally, from the protected areas of Grindstone Creek Marsh areas separated from the creek by a berm, another 3,413 have been removed over the last 22 years. Many of these fish were returned to the harbour system directly. Overall, few new carp are being added to the system contributing to the ongoing decline of the carp population (Figure 22).

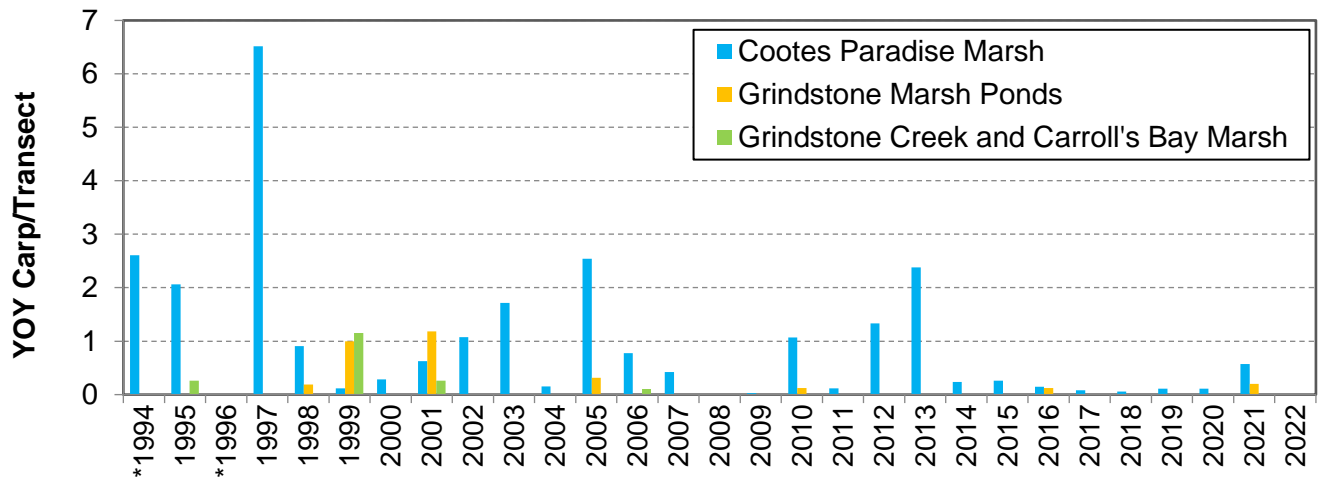
Figure 14. Mean number of YOY Common Carp (and hybrids) caught in August electrofishing transects, by year, for Cootes Paradise Marsh, Grindstone Marsh Ponds, and Grindstone Creek and Carroll's Bay Marsh.

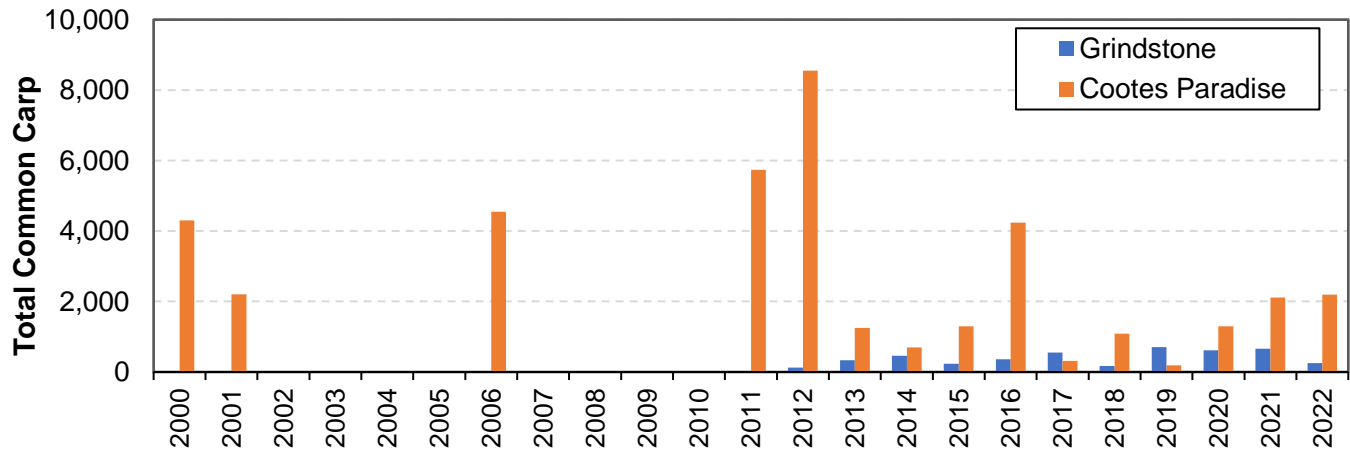
Figure 15. Total number of Common Carp removed from Cootes Paradise and Grindstone Marshes from 2000 - 2022. *The Grindstone Marsh numbers only include carp removed from protected areas.

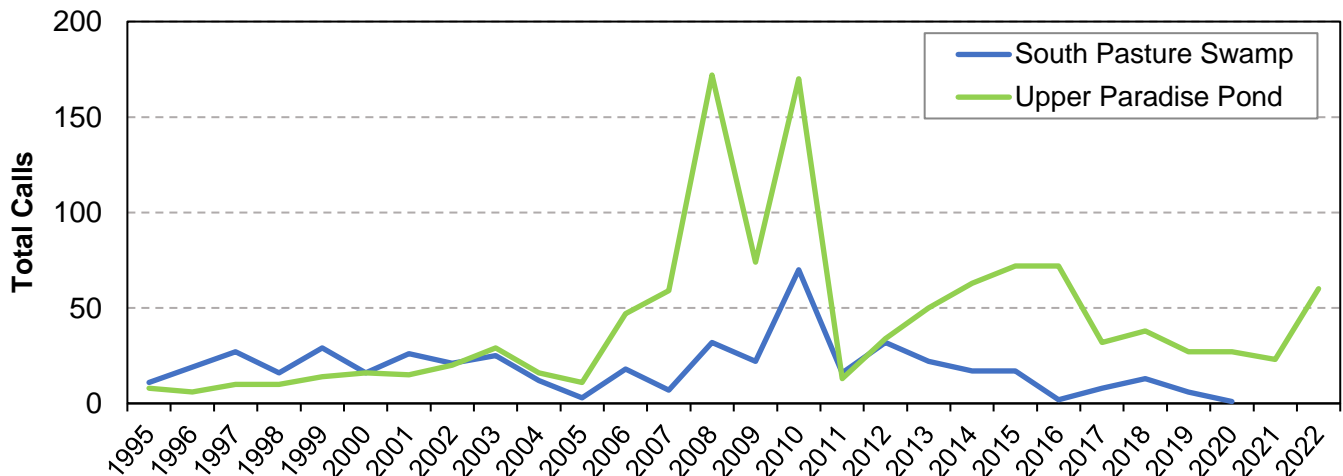
Figure 16. Trend total calls heard annually (3 visits pooled -Marsh Monitoring Program) at the highest quality habitat sites for amphibians (Upper Paradise Pond -Cootes Paradise, South Pasture Swamp -Grindstone Marsh).

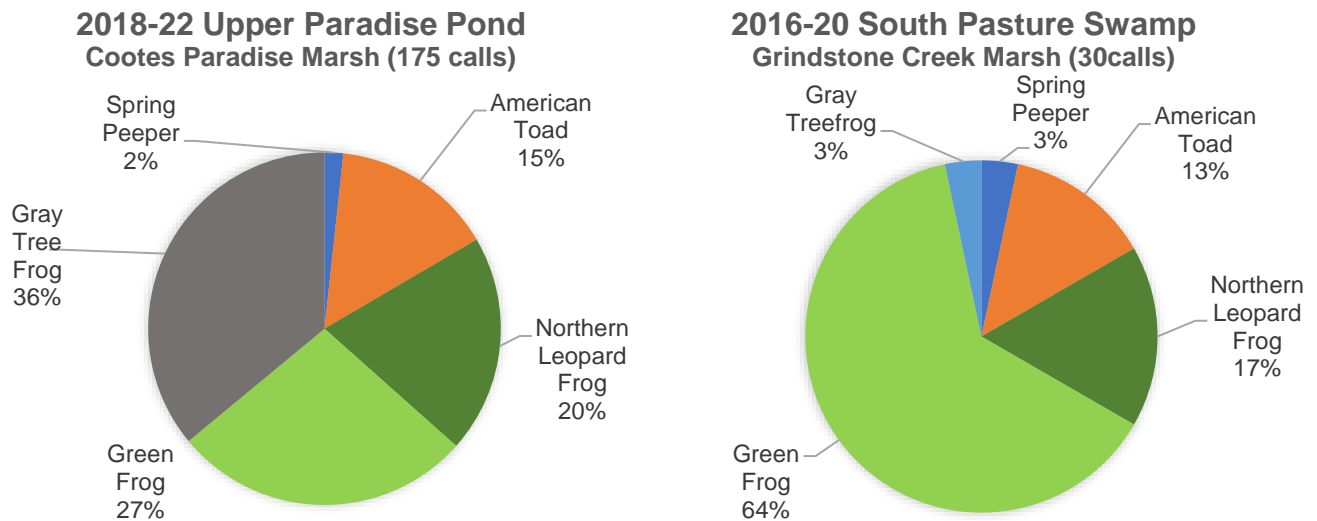
Figure 17. Amphibian species Marsh Monitoring Program at the highest quality habitat stations including Upper Paradise Pond Cootes Paradise (175 total calls) and South Pasture Swamp Grindstone Marsh (30 total calls). Both sites are oxbow ponds supplied by localized spring water and within upstream areas of the coastal marsh.

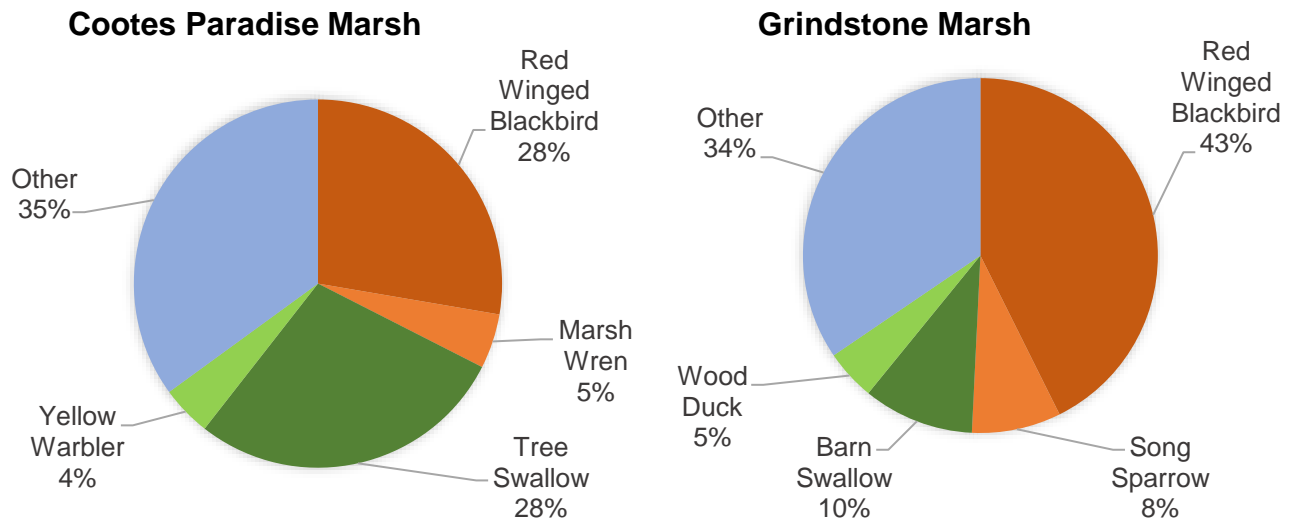
Figure 18. 5-year total for most common bird species for most common birds between 2017-2022, Marsh Monitoring Program (Cootes Paradise 6-14 sites, Grindstone Marsh - 6 sites).

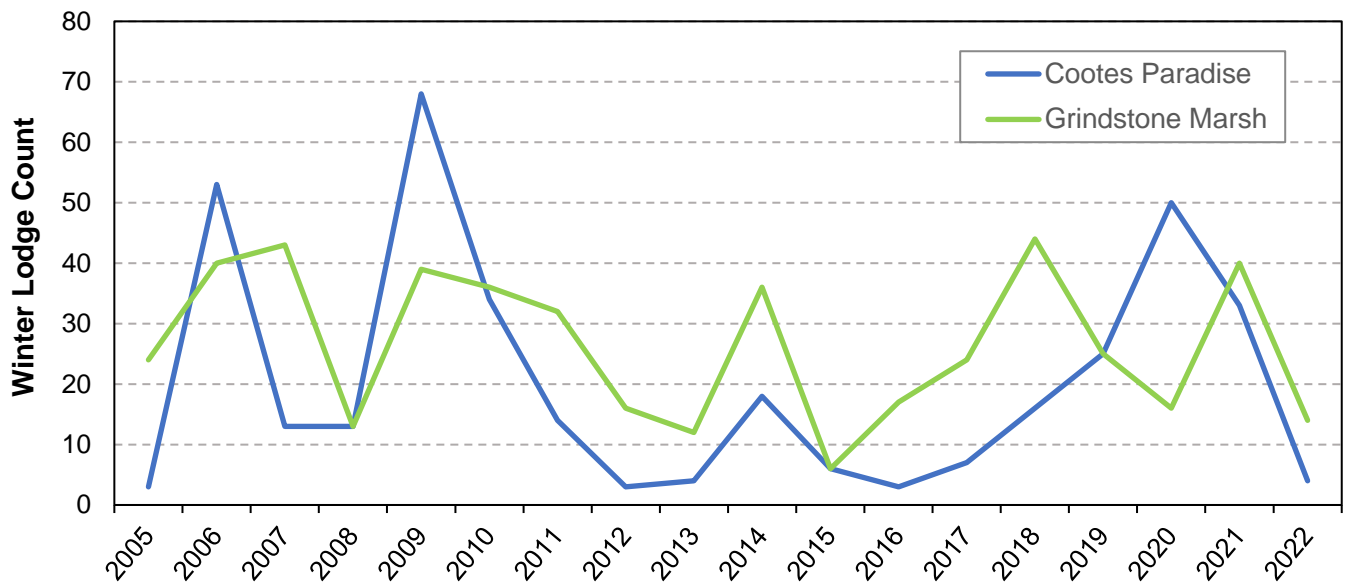
Figure 19. Trends in Muskrat lodge winter count for Cootes Paradise and Grindstone Marsh.

Muskrat populations have grown considerably (Figure 19). Based on current winter lodge counts of 2021 and 2022 (Grindstone Marsh 40, Cootes Paradise 33) it is estimated that both marshes have muskrat populations of between 100-200 animals as of the end of 2022. Lodges concentrate in two locations, the interior oxbow ponds and the banks of the main creek channels of each marsh. The interior ponds are in the upstream portion of each marsh, and during the fall season is where native emergent plants remain flooded during Lake Ontario's typical fall water level decline. In addition to the pond lodges a few muskrats are found in bank tunnels along the lower channels of Spencer and Grindstone Creek where water is flowing. However, the number of dens is unknown as entrances are submerged under rising creek flows. Fall 2021 and 2022 had water levels that precluded muskrats from utilizing other areas of the marsh (Figure 32) and this is not uncommon most years due to reduced extend of emergent vegetation.

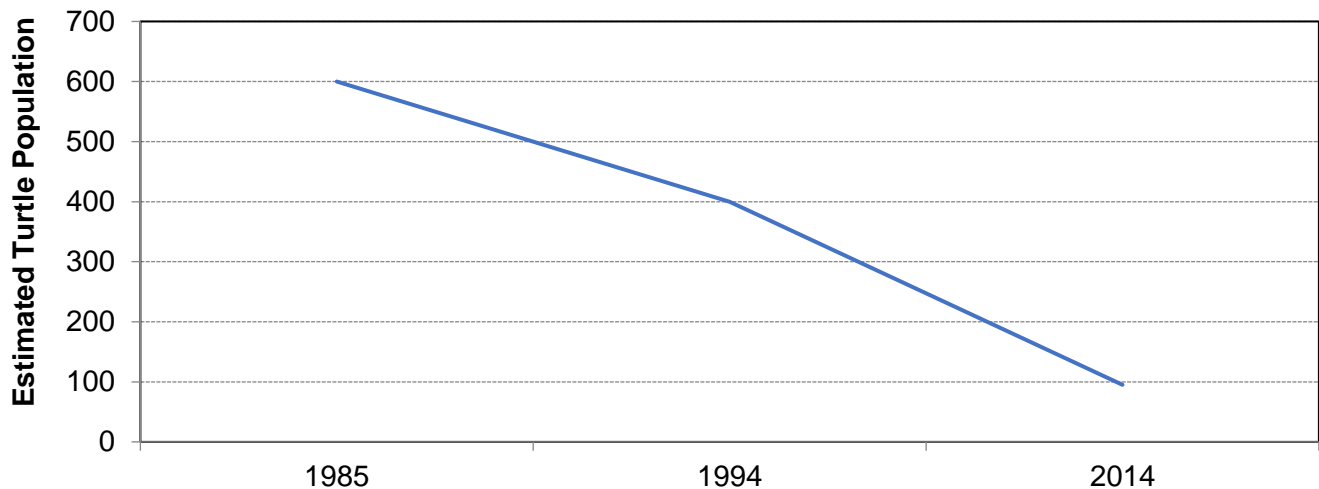
Cootes Paradise Snapping Turtle Population Trend

Figure 22. Trend of Snapping Turtle population in Cootes Paradise (Harrison & Theysmeyer 2014)

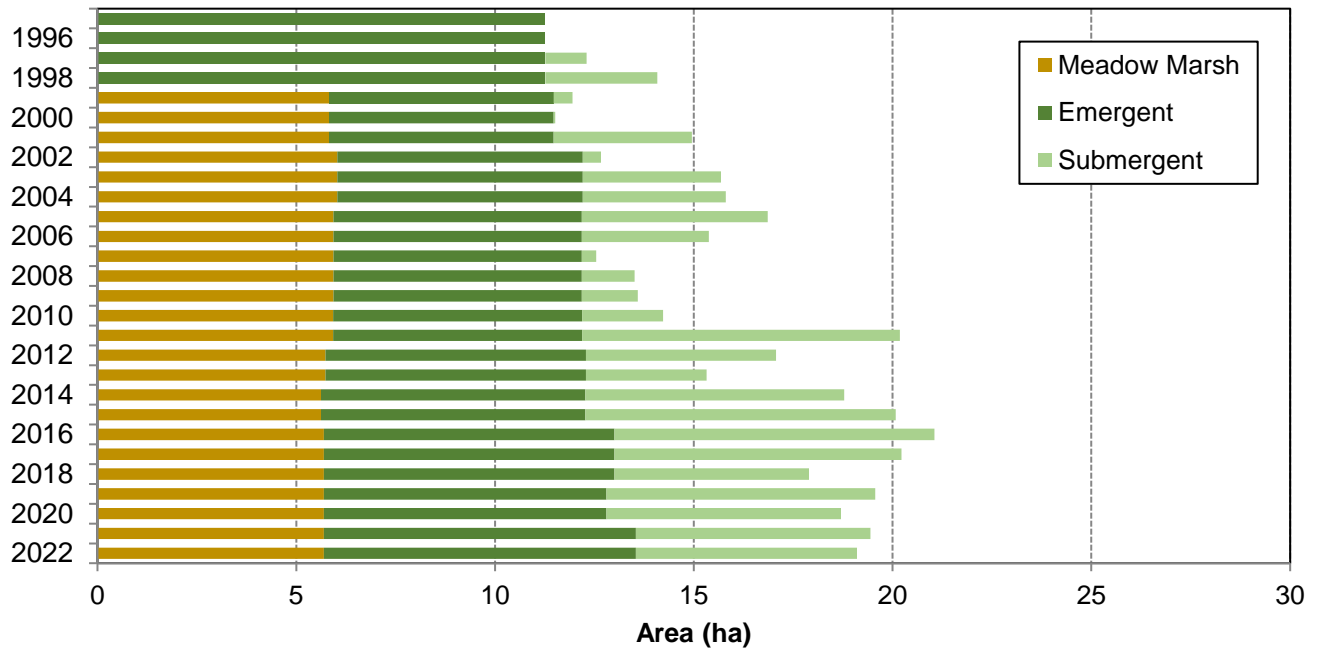
Figure 24 Total marsh vegetation in Cootes Paradise Marsh (above) and Grindstone Marsh (below), including meadow marsh, emergent, and submerged vegetation as measured in early July (submergent/floating leaf area). * Indicates that submergent wasn't measured that year.

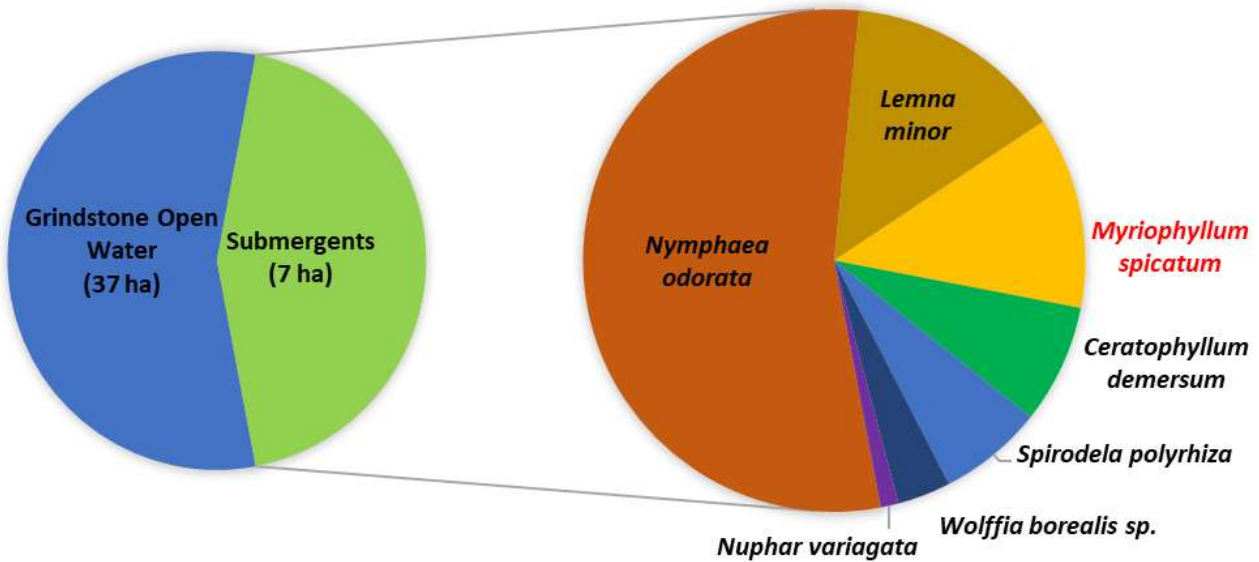
Figure 25. Aquatic plant community composition. Upper chart Cootes Paradise Marsh, lower chart Grindstone Marsh.

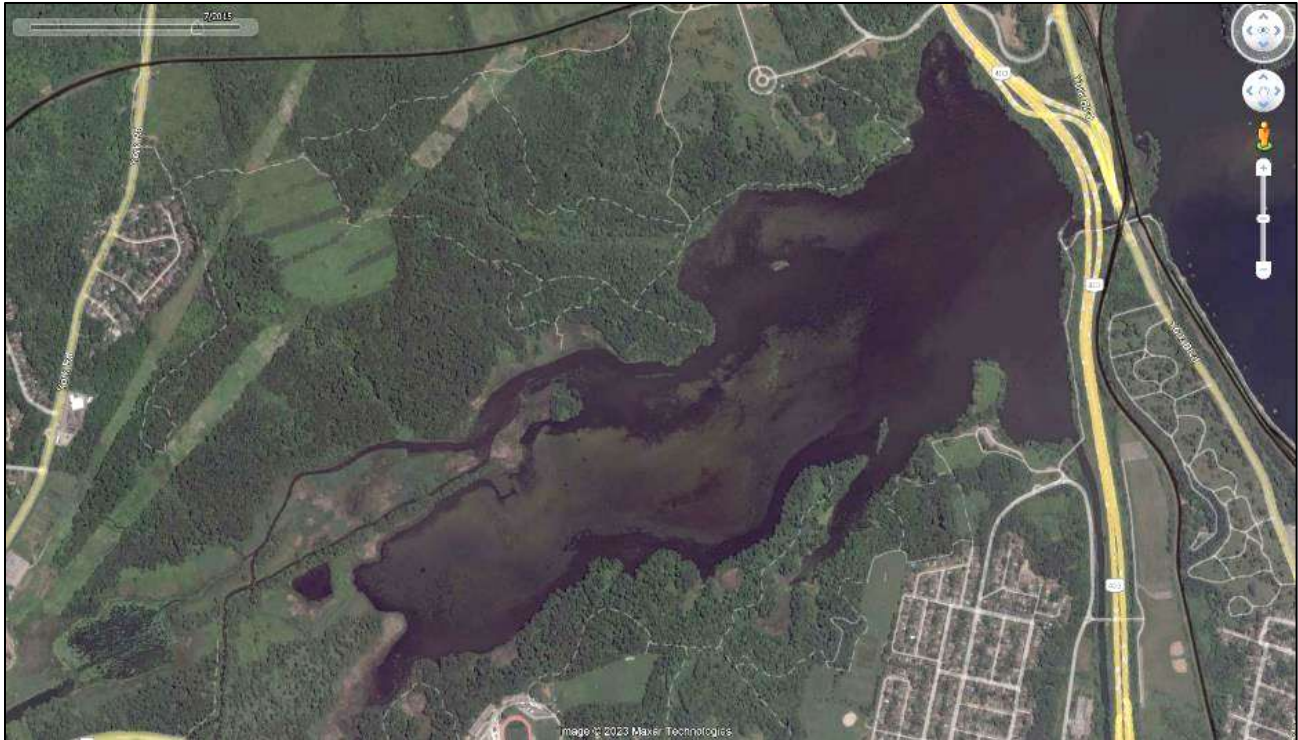
Figure 26. Aerial imagery of Cootes Paradise in July 2015, showing the area dense aquatic vegetation as well as the missing vegetation in the flow of Spencer Creek. Vegetation present prior to a late June rainstorm.

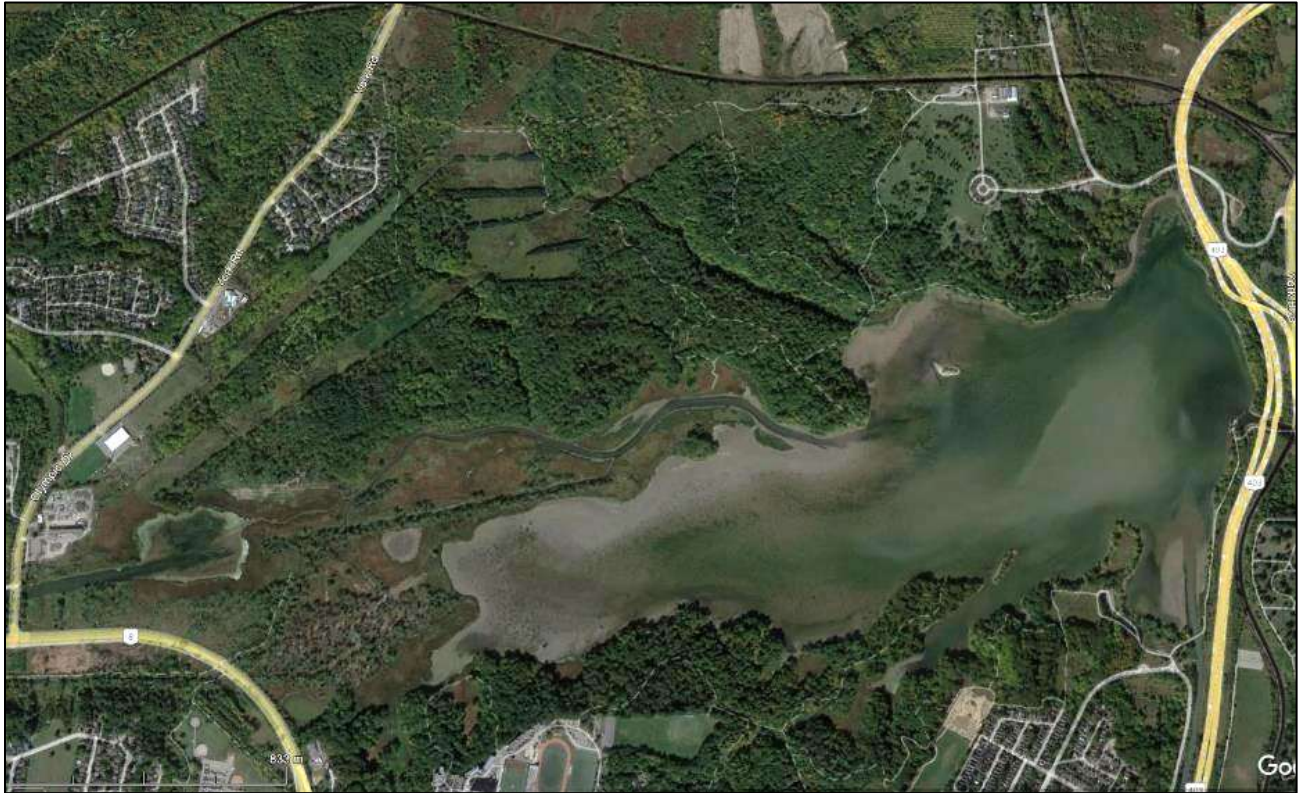
Figure 27. Aerial imagery of Cootes Paradise in October 2022, showing the area that dried out in the marsh, and scattered aquatic plant patches in the remaining water areas. Water level was low at about 74.6masl.
