Royal
Botanical
Gardens
CANADA

2022 Status Update of Fish and Wildlife Populations and their Habitat in Cootes Paradise and Grindstone Coastal Marshes in support of HHRAP

Tys Theijsmeijer
Aleksandra Rebalka
Jennifer Bowman
Ecological Stewardship Department
Royal Botanical Gardens
June 2024
Royal Botanical Gardens
P.O. Box 399
Hamilton, ON L8N 3H8
Canada

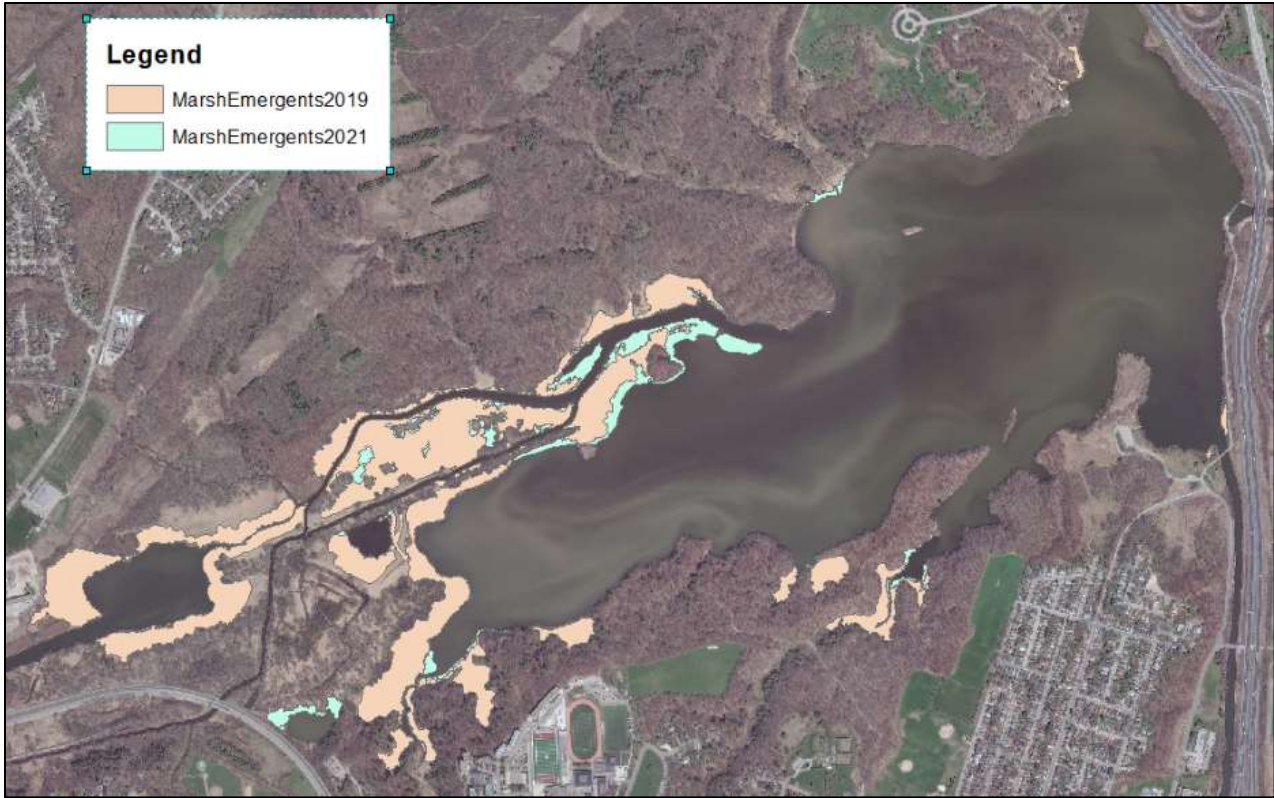
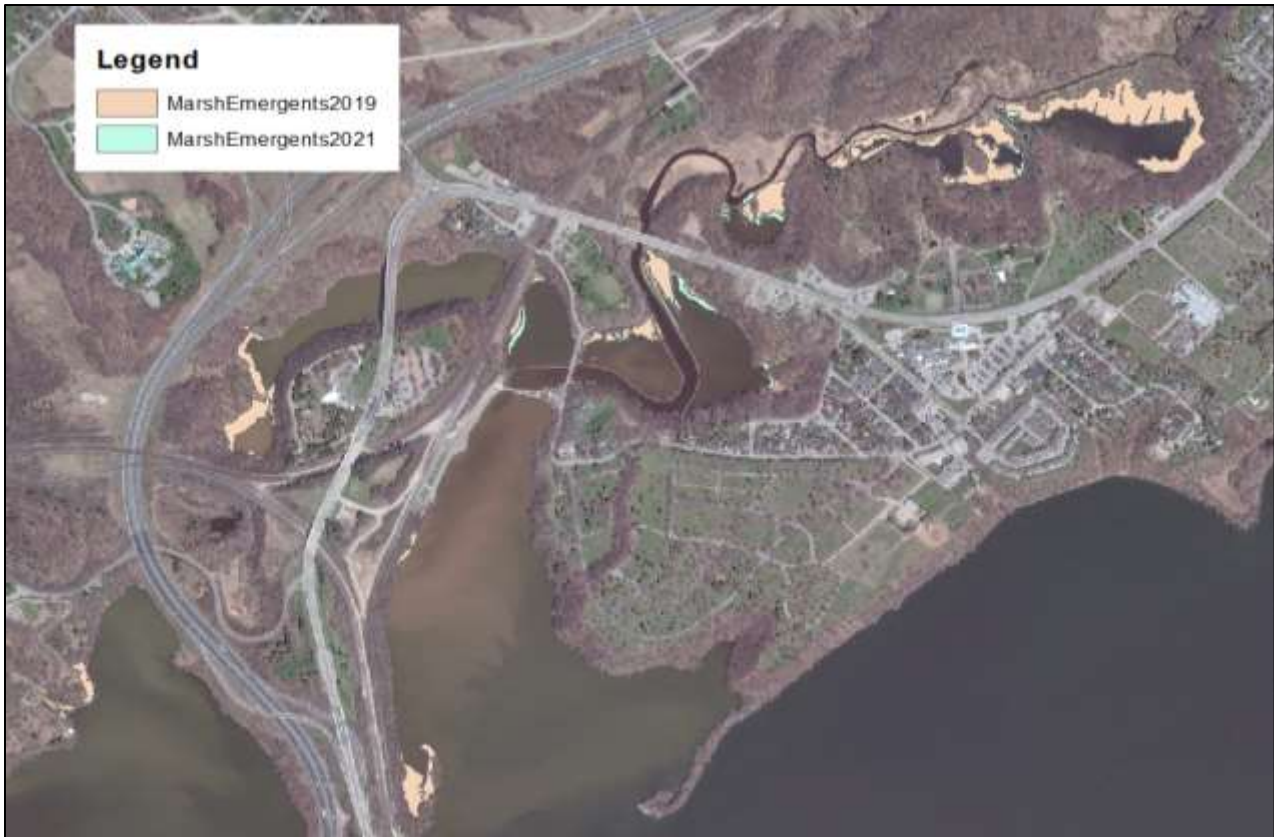
Figure 28. Maps of emergent vegetation cover gained in Cootes Paradise (top) and Grindstone Marsh (below) during 2021 low water as of 2022.

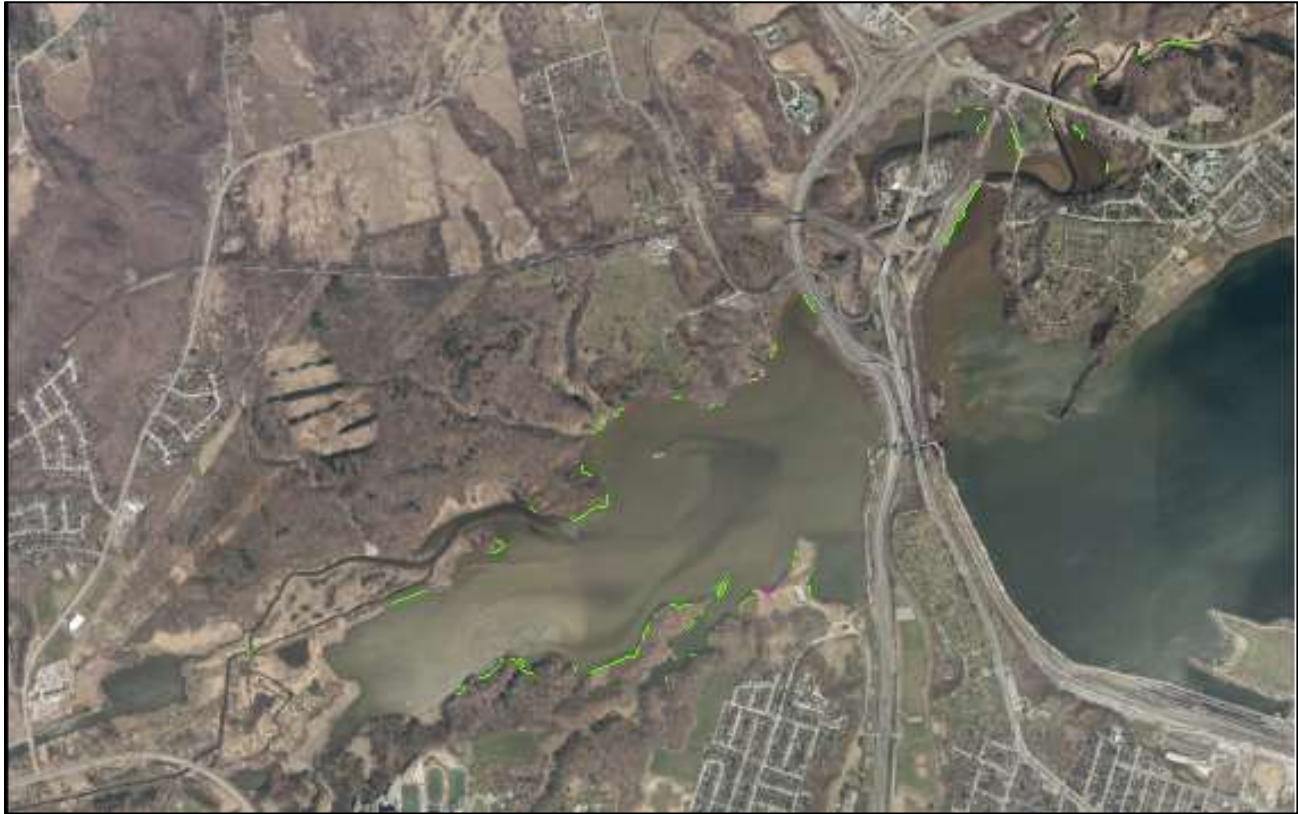
Figure 30. Shoreline Bioengineering and planting sites for Cootes Paradise and Grindstone Marsh as of 2022.

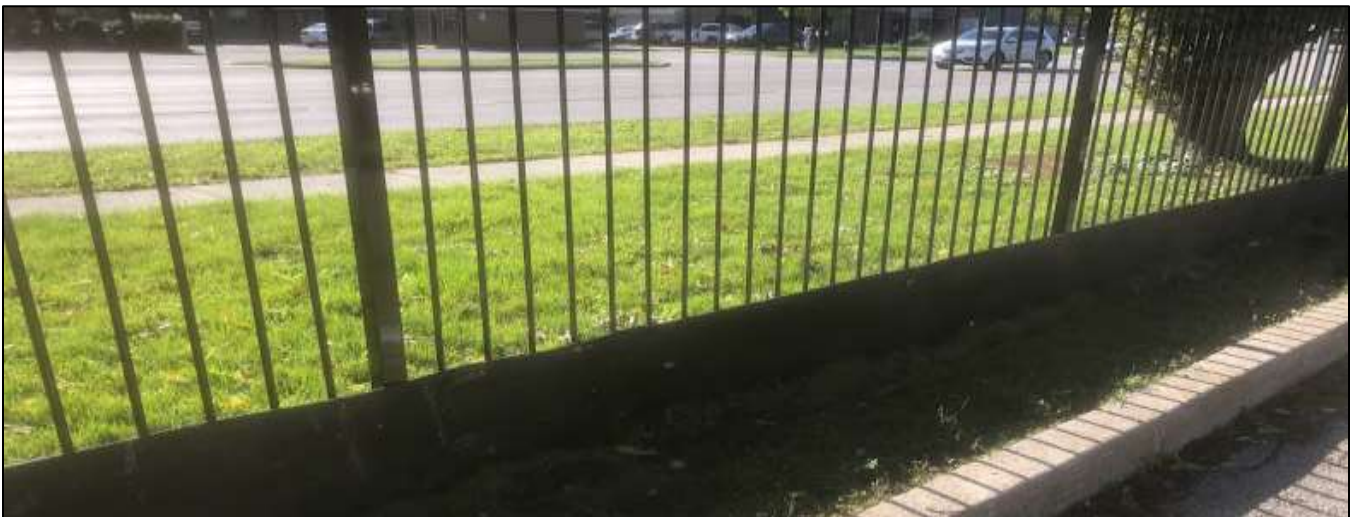
Figure 37 Roadkill mitigation small animal fence, ongoing installation at Cootes Paradise and Grindstone Marsh.

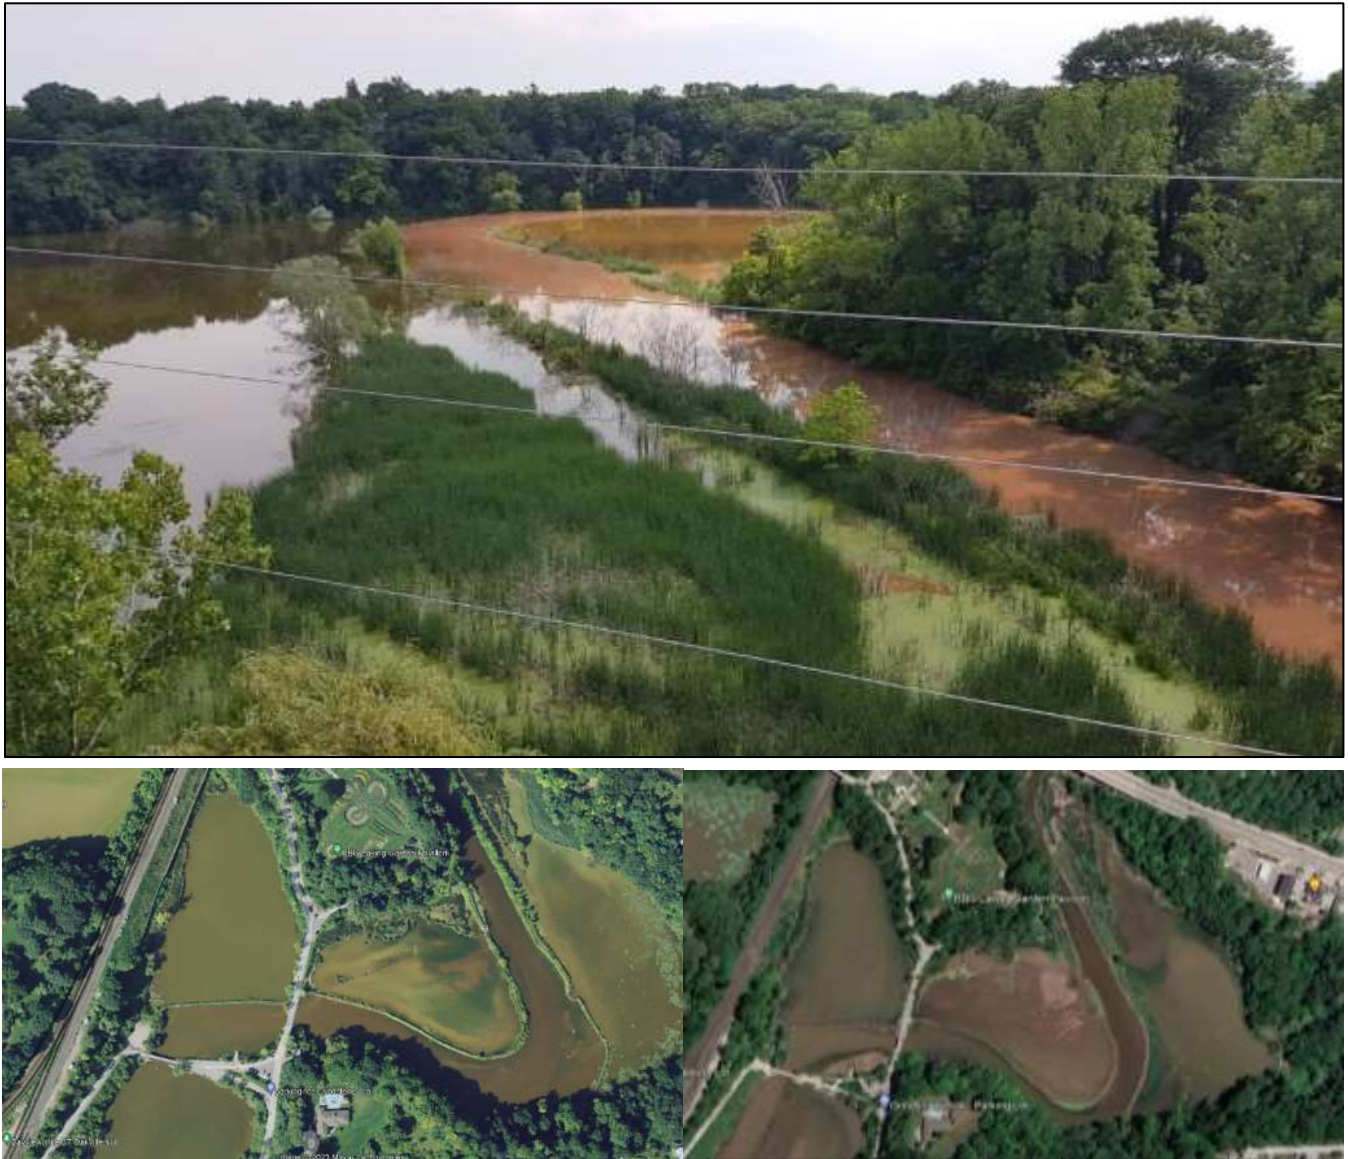
Figure 44. Berm realignment changes shown between 2009 and 2021 of Blackbird and Osprey marshes. The berm was realigned to better match the natural sinuosity of Grindstone Creek.

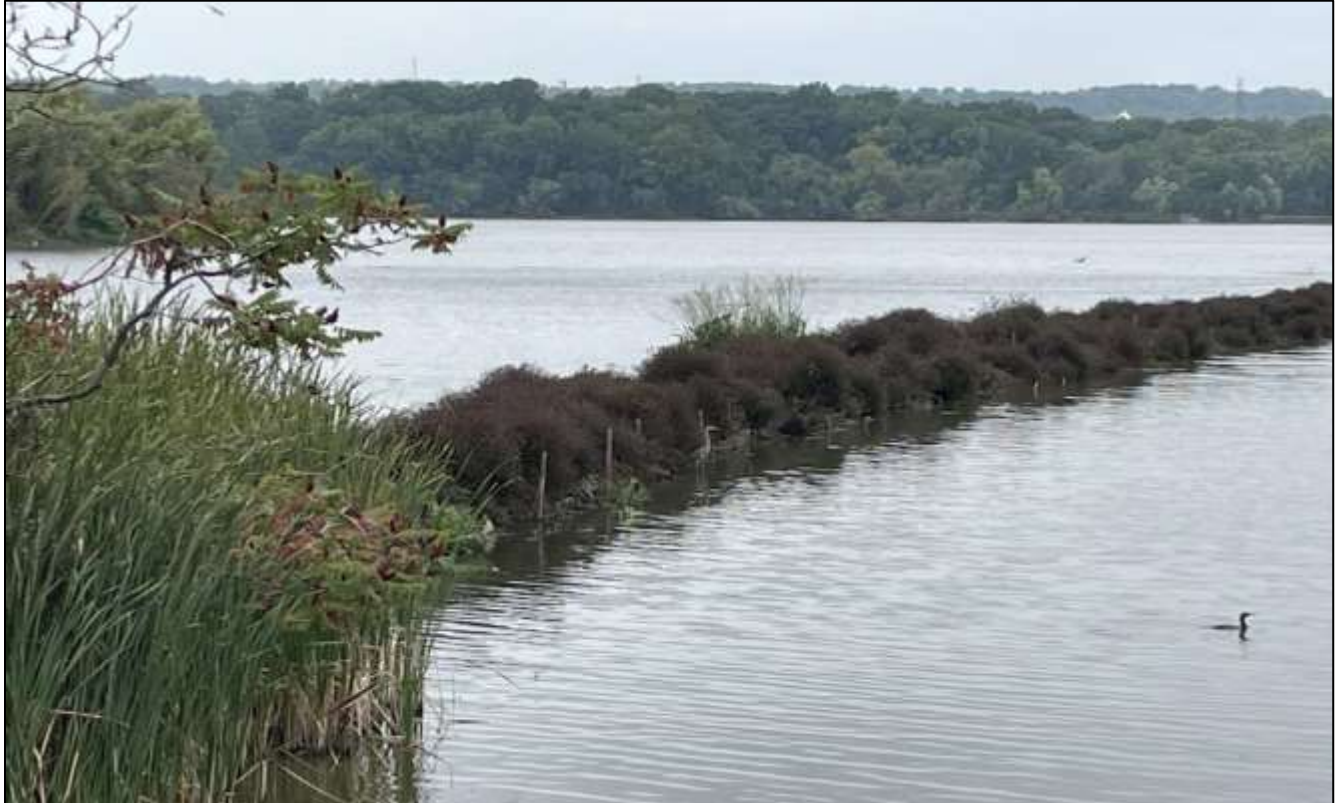
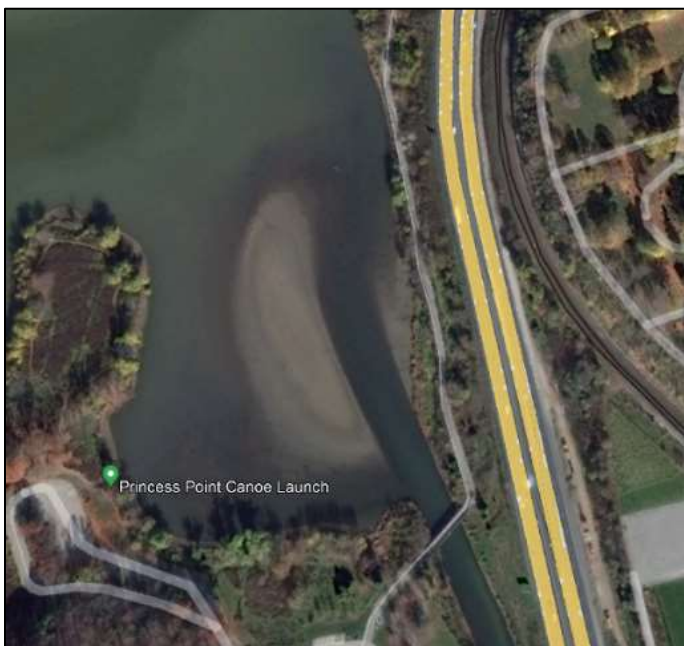
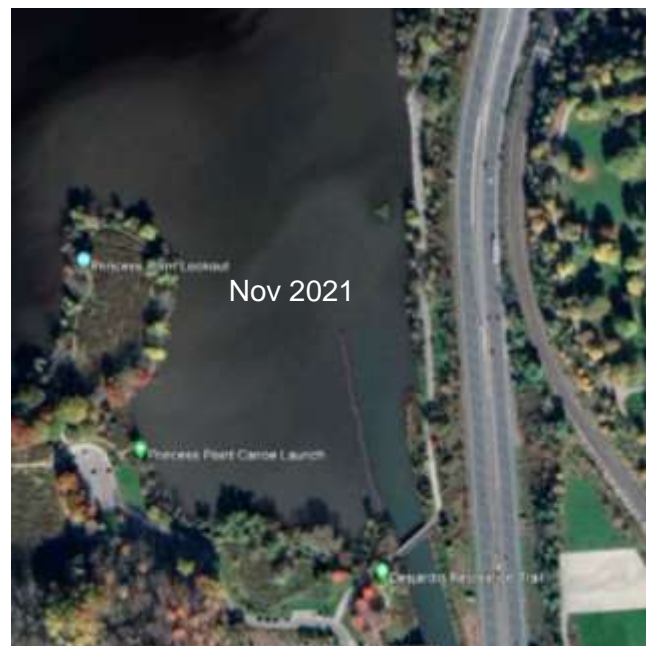
Figure 45. Pre (right) and post (left) berm construction at the mouth of Chedoke Creek
